COLUMBIA, CONNECTICUT  
**MONO POND DAM**  
**CT 00258**

PHASE I INSPECTION REPORT  
NATIONAL DAM INSPECTION PROGRAM

AUGUST 1980

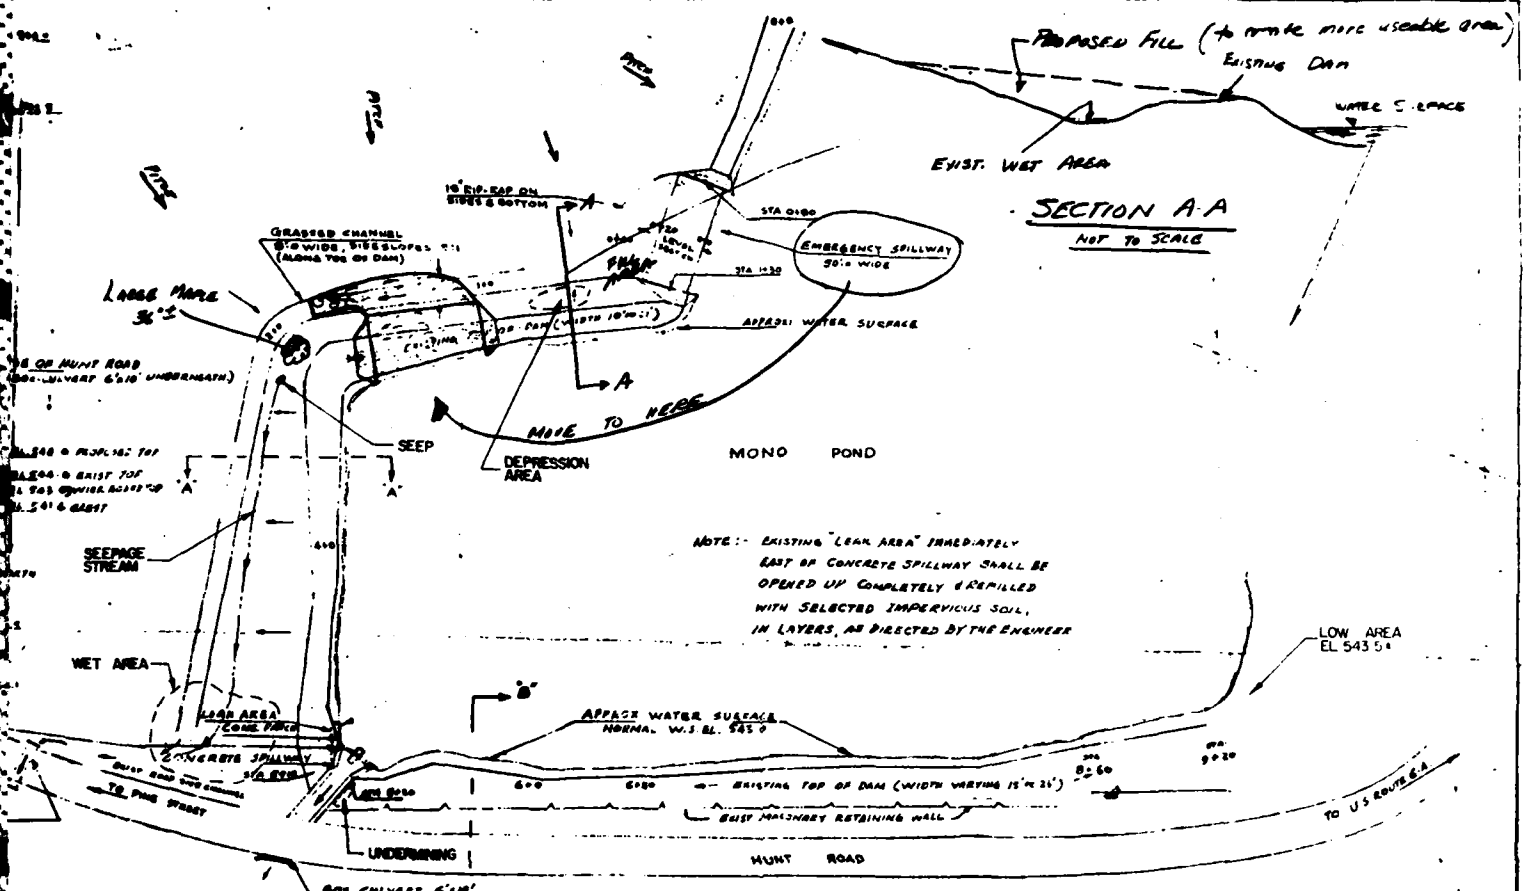
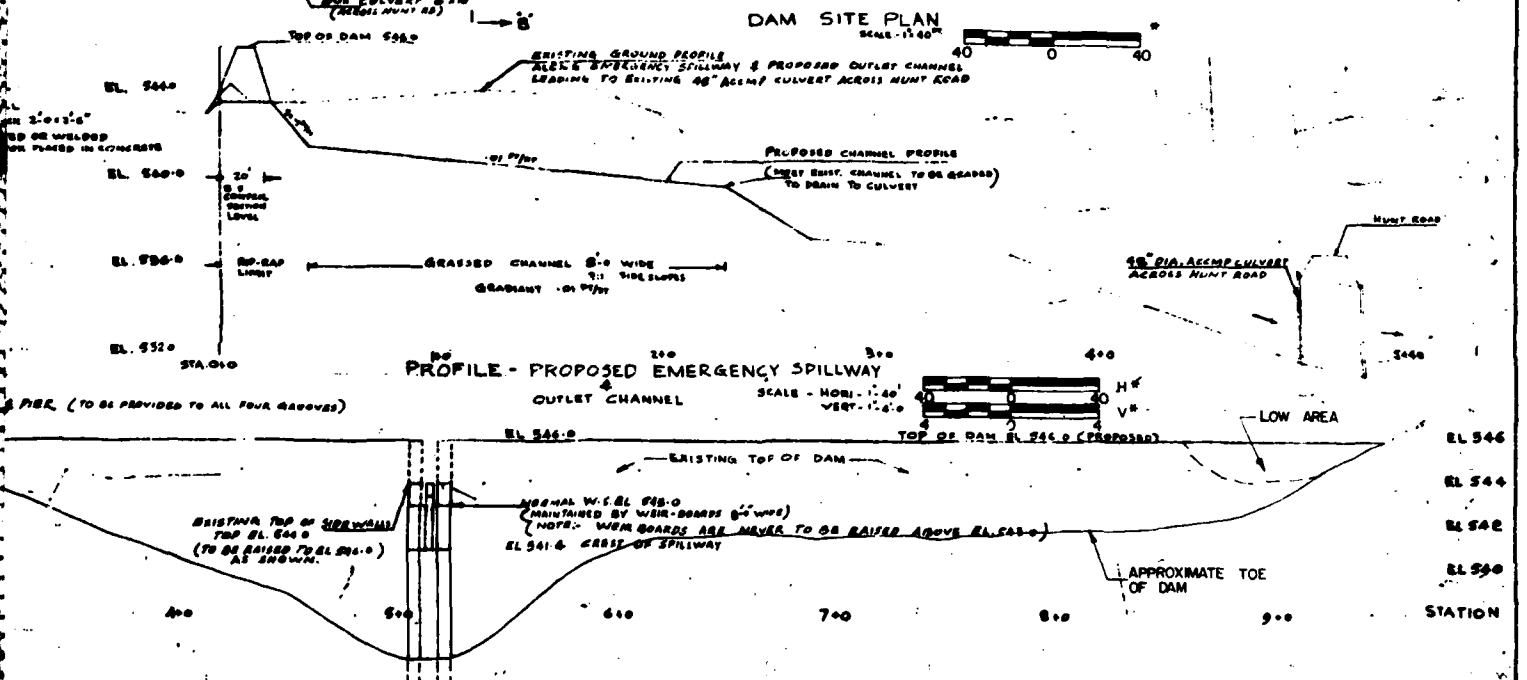
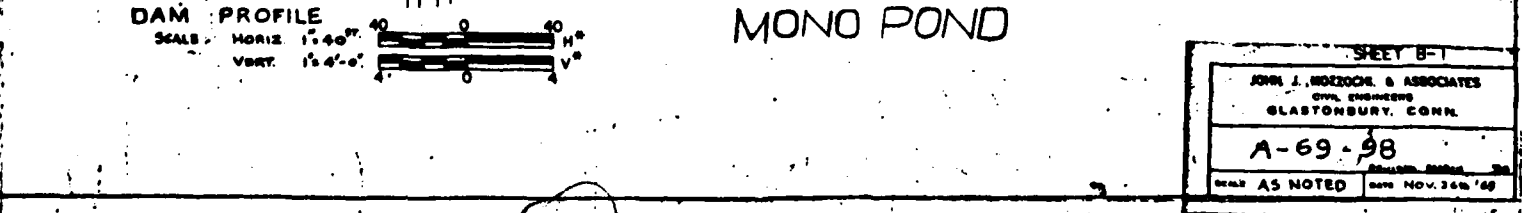
SHEET B-1

A large swampy area was observed at the toe of the right embankment, just right of the principal spillway and in the area where the emergency spillway channel flattens out and becomes non-distinct (See Sheet B-1).

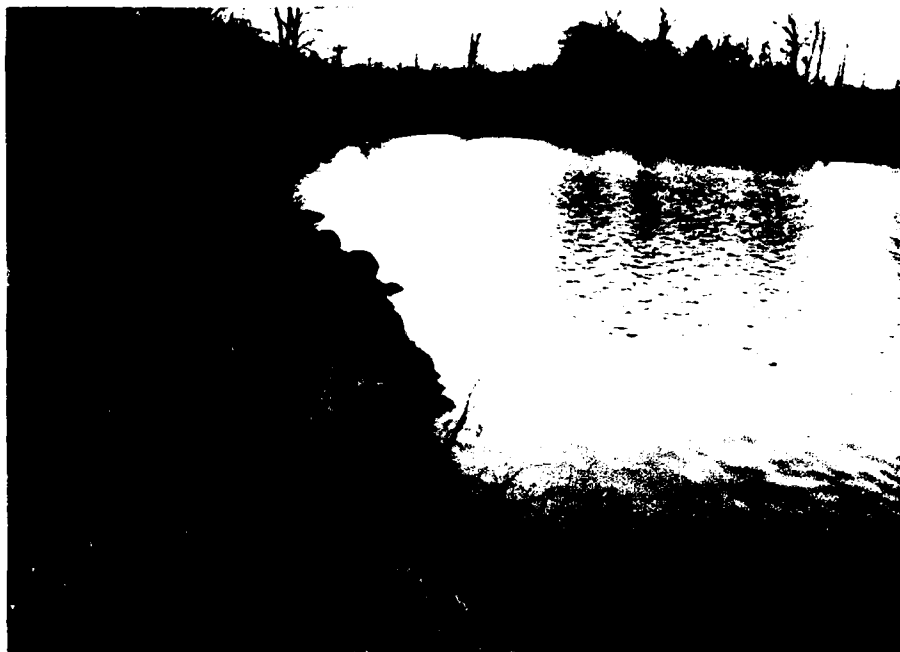
Upstream Slope - The upstream slope has little or no riprap at and above the waterline. This lack of riprap is causing erosion from wave action with some slight sloughing, making the upstream slope quite irregular (Photo 1). Some thin clumps of brush and small trees were also noted along the upstream slope.

Photo 1 - Upstream slope of embankments left and right of principal spillway. (April, 1980)

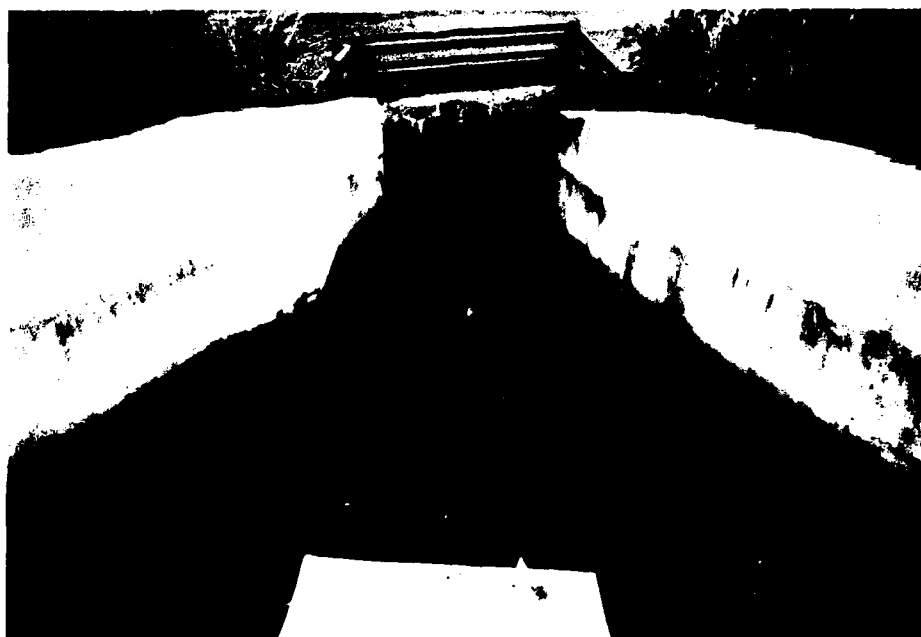
Photo 7 - Principal spillway from upstream (July, 1980).
